## Preliminary Geotechnical Feasibility Report

## Phase 2 Final SWMF Site Evaluation – Moon Pit

### **Preliminary Geotechnical Feasibility Report**

February 2024

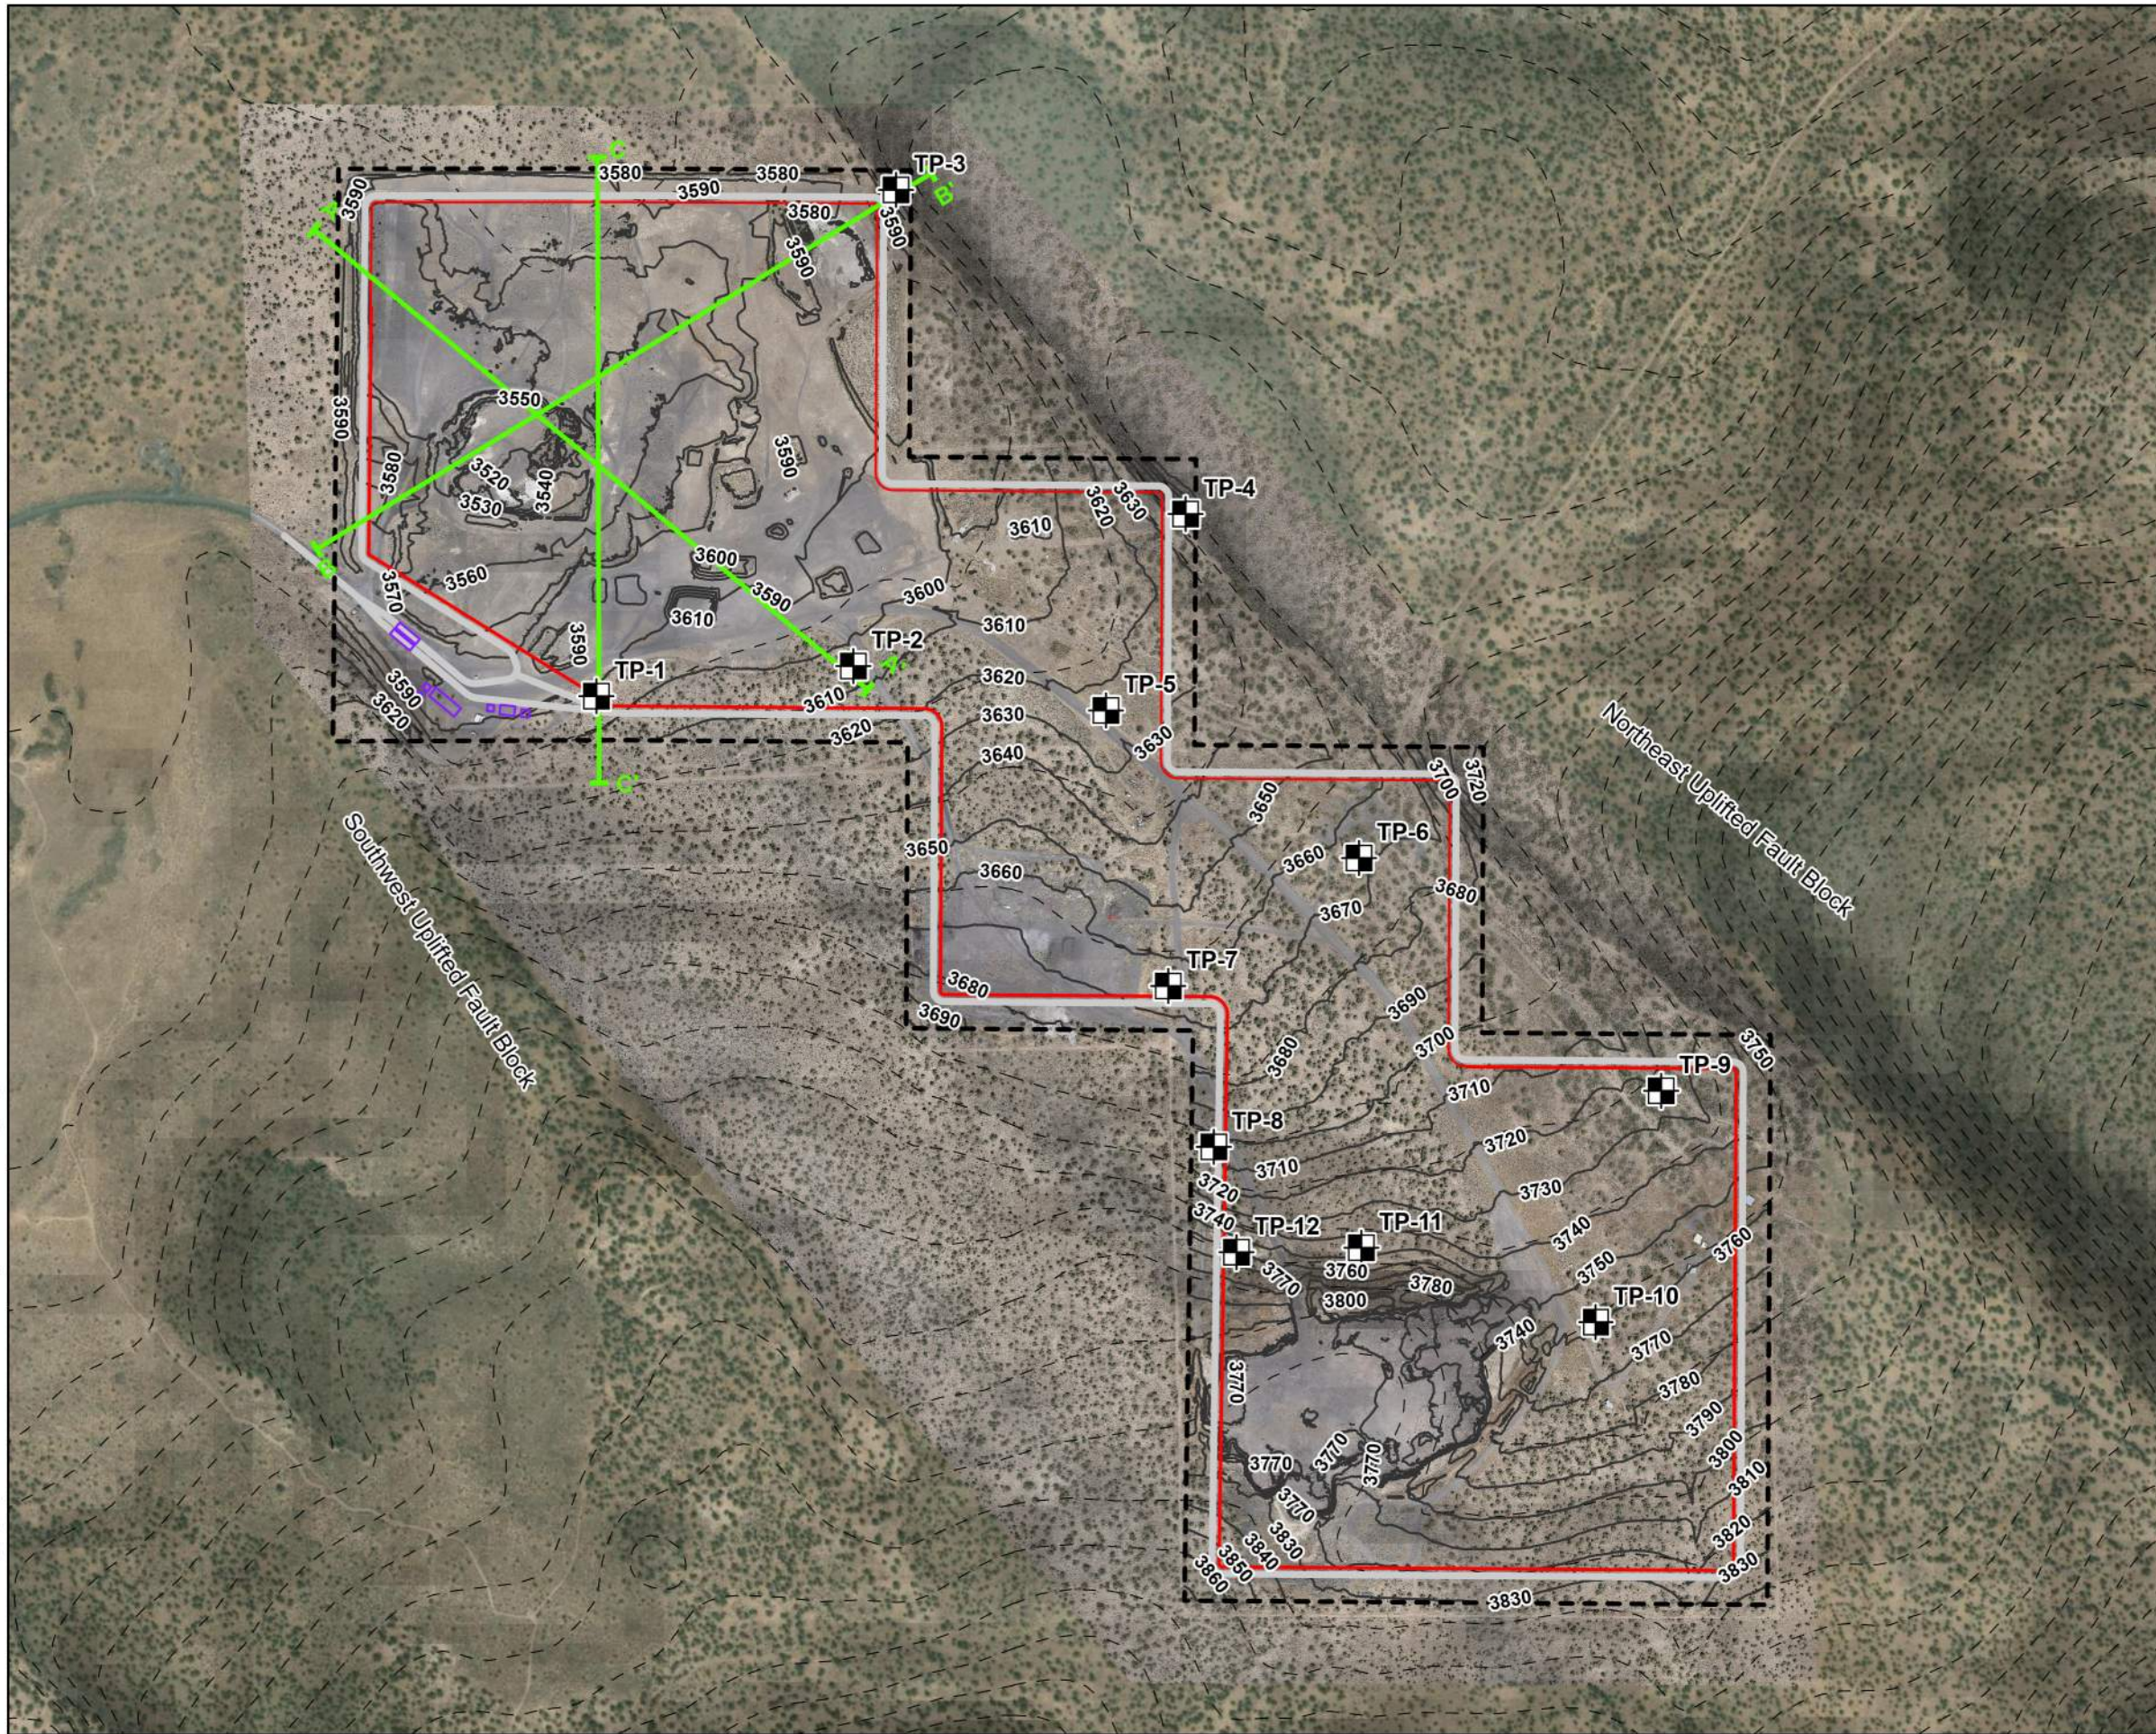
**1**

- TP-1 - Test pit name and approximate location
- 10-foot elevation contour (Parametrix, 2023)
- 20-foot elevation contour (USGS; NAVD 88)
- A-A' - Geophysical profile name and approximate location (Siemens & Associates, 1996)
- Preliminary Site Layout (Parametrix, 2023)**
- Approximate location of structures
- Approximate footprint of waste cells
- Approximate property boundary
- Approximate location of proposed access road

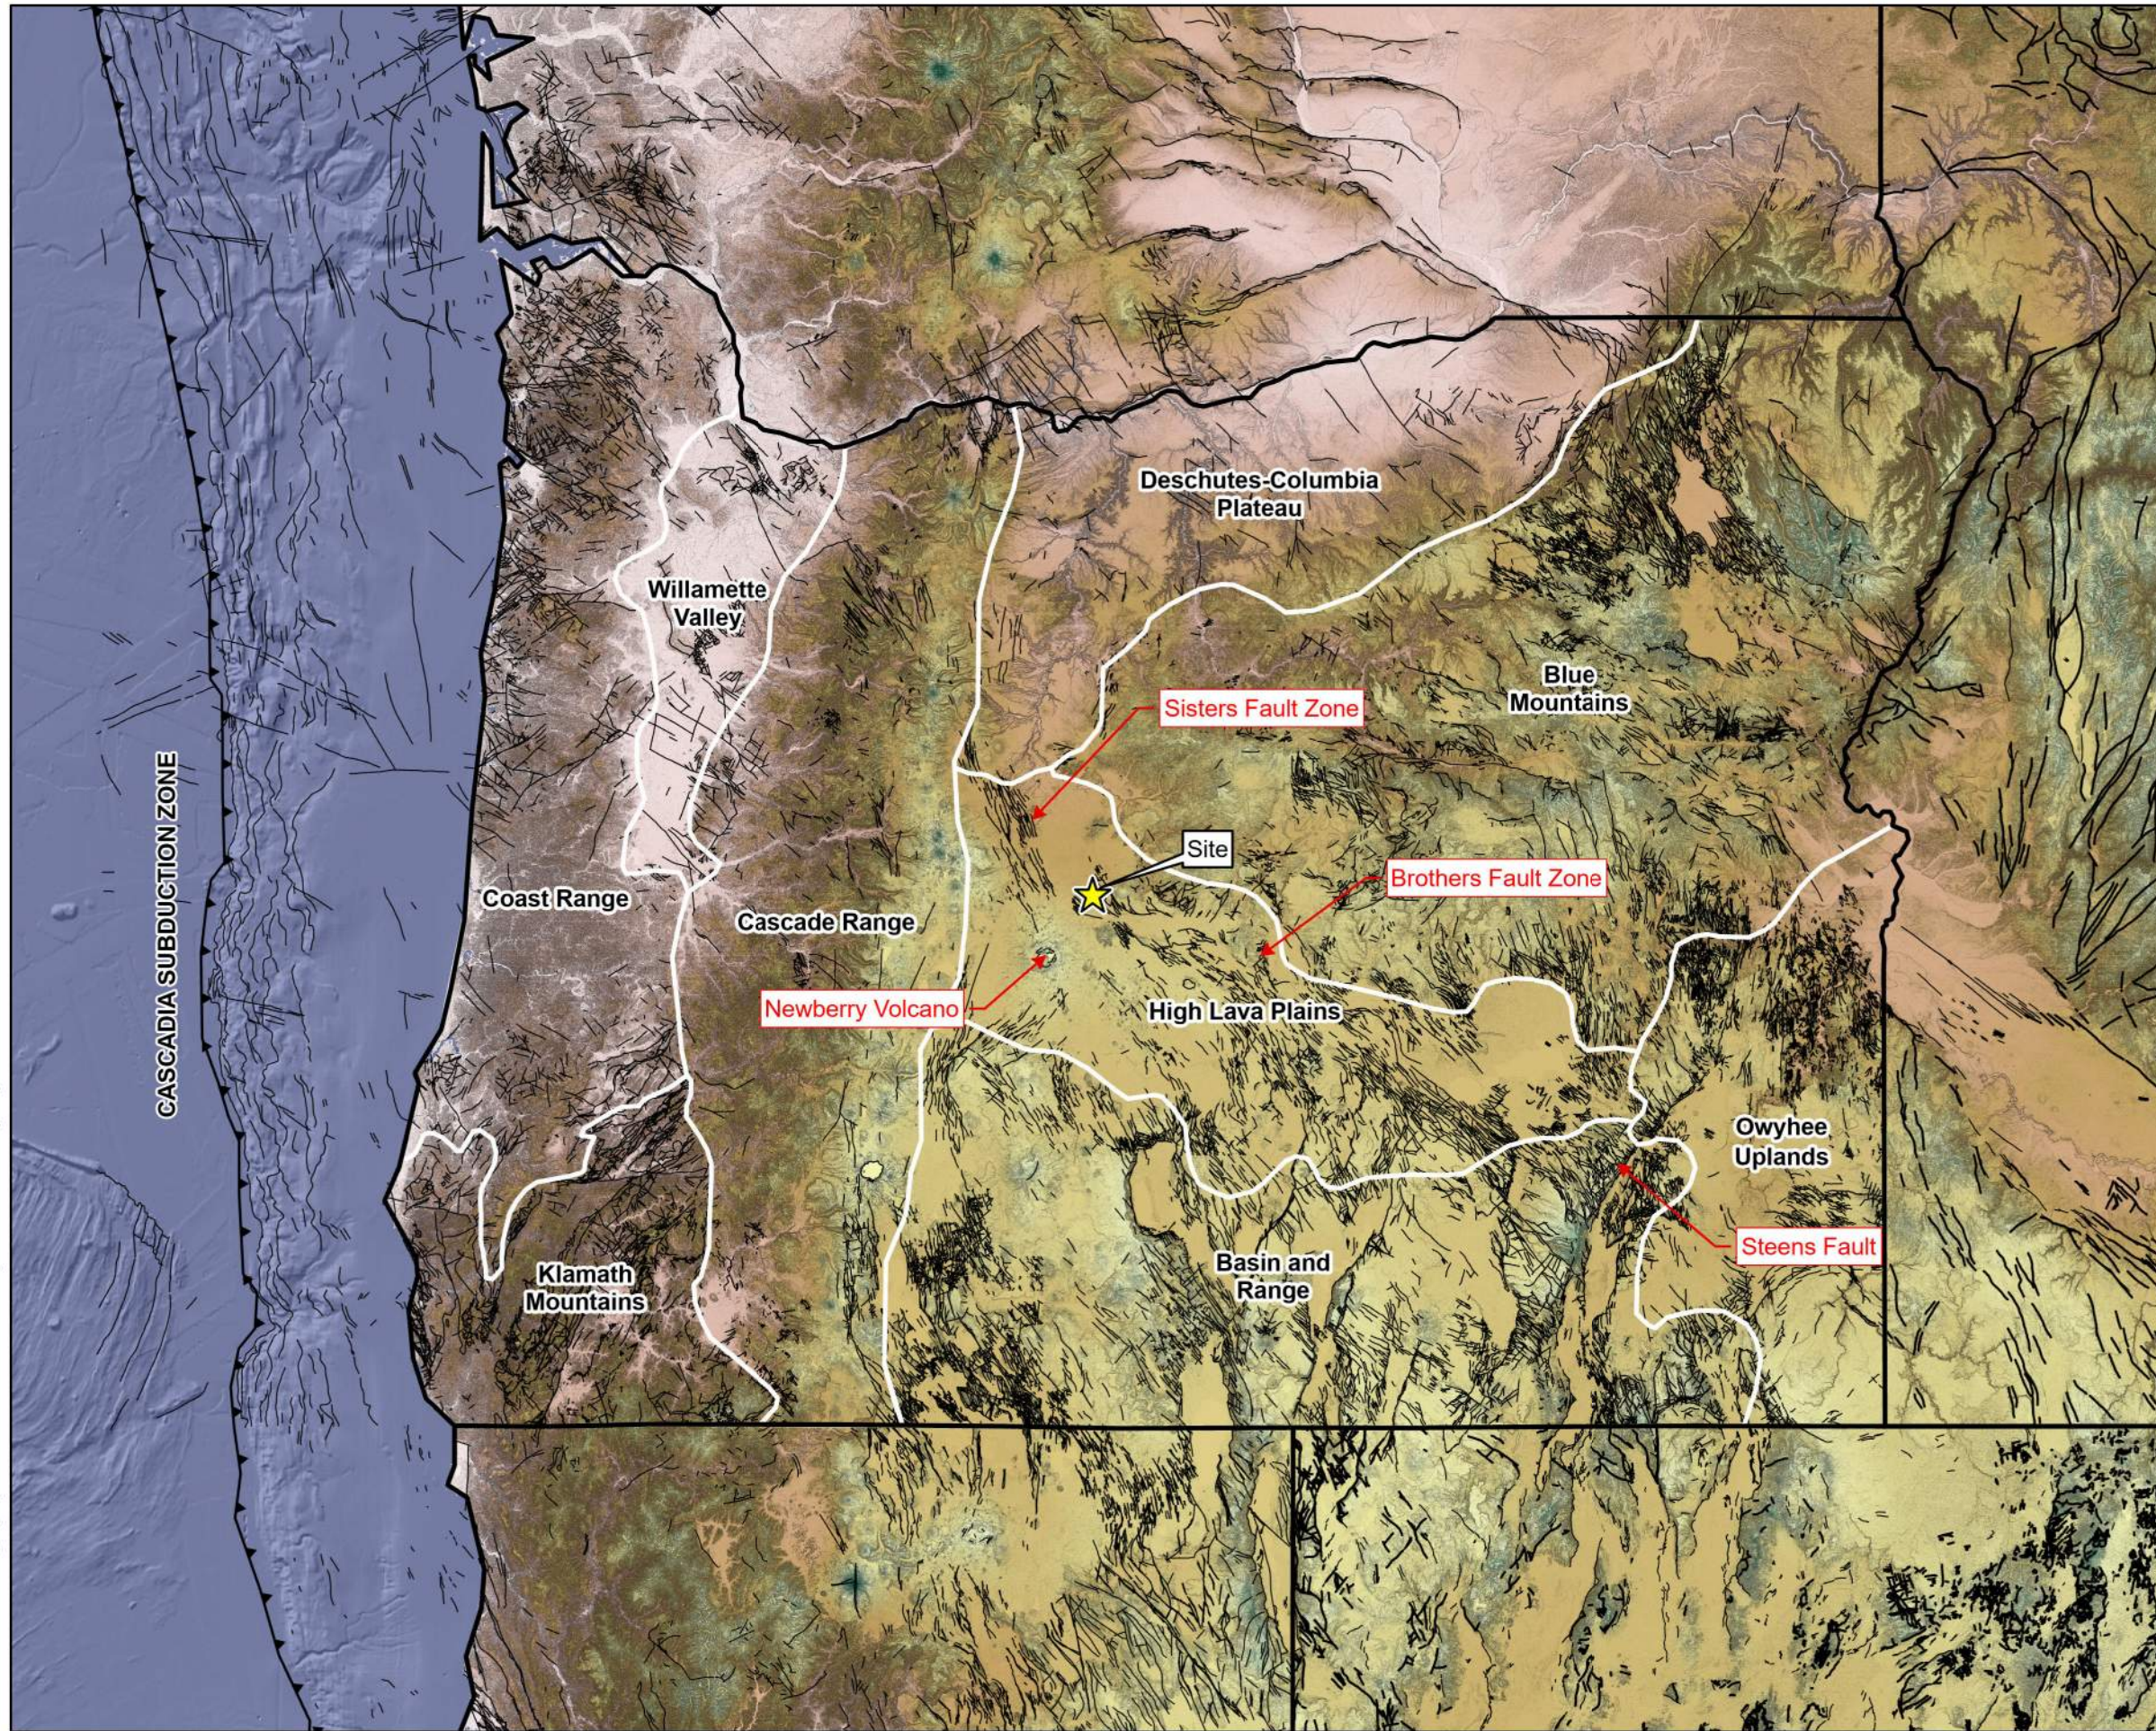
**2**

- EXPLANATION**
- ★ Site location
  - Cascadia Subduction Zone (CSZ)
  - Fault - Age undifferentiated

- Notes:
1. SRTM 30-meter elevation model
  2. Faults compiled from USGS Quaternary Fault and Fold dDatabase, DOGAMI OGDC-7 (2020), WA DNR DS-18 (2019), USGS OFR-2005-1305 (2007), IGS M-9 (2012)
  3. Cascadia Subduction Zone geometry obtained from USGS Cascadia Subduction Zone database (2022)

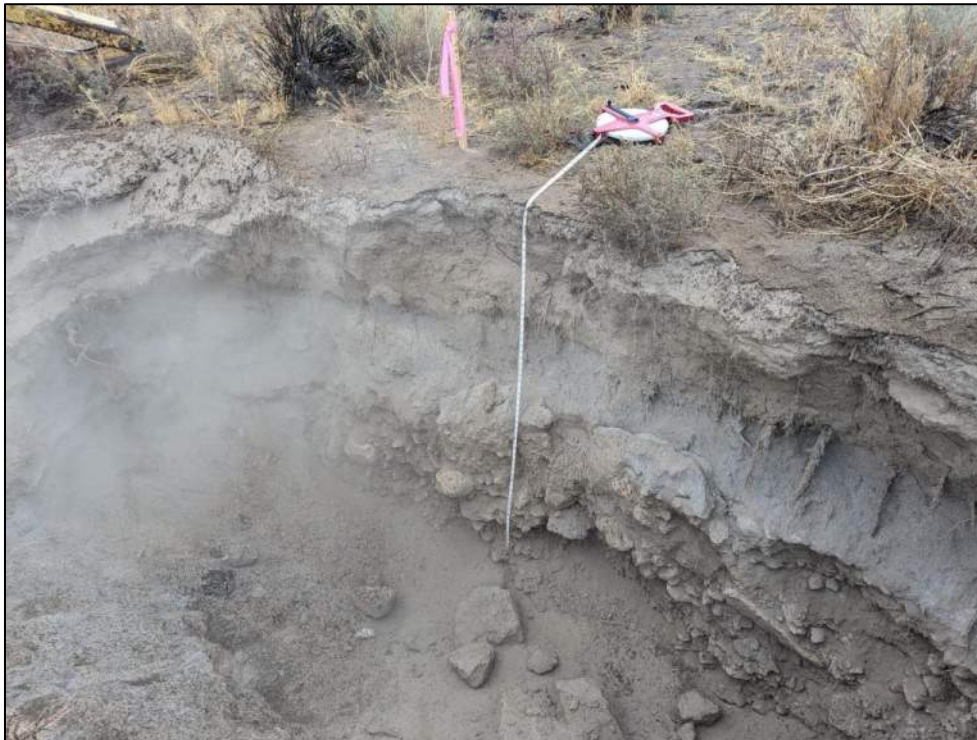
**Photo 2.** Subsurface materials in TP-5 with more of a well-defined interbed appearance.

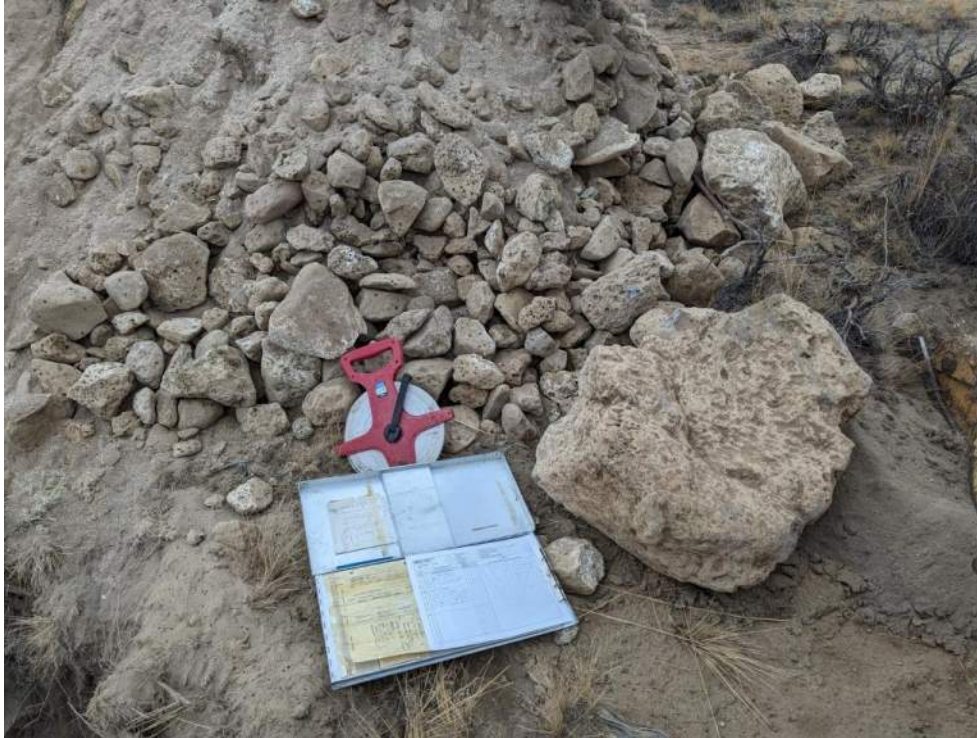
**Photo 3.** Spoils from TP-12 with large pumice cobbles and boulder. Tape measure and note case for scale.

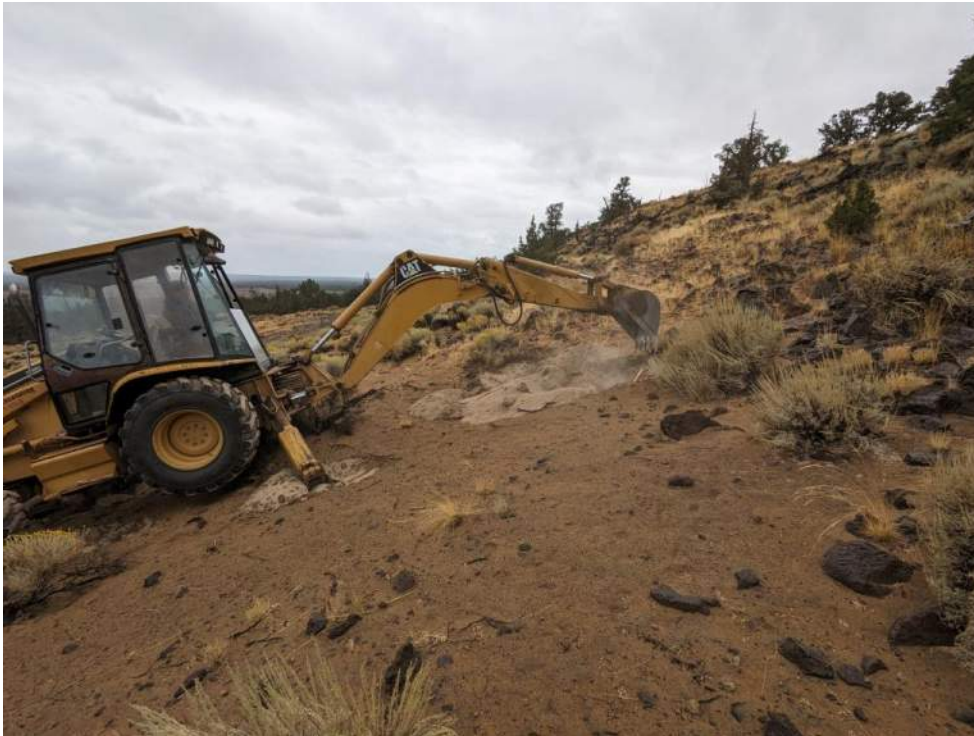
**Photo 4.** Backhoe excavating into the toe of the slope at the location of TP-4. Sandy colluvium with cobbles and boulders from upslope bedrock.

- Colluvium:** Colluvium was encountered in test pit TP-4, at the surface to 6.0 feet bgs; and TP-3, below the loess from 1 to 7 feet bgs. Both test pits were terminated within the colluvium unit. Dense roots were noted in the colluvium of TP-4. The colluvium soil was characterized as dry, light brown, well-graded gravel (GW) with sand, cobbles, and boulders. Clasts were subrounded to subangular. Boulders with a maximum size of 18 inches were present in TP-3 and trace quantities in TP-4. This colluvium is predominantly located along the toe of adjacent slopes.

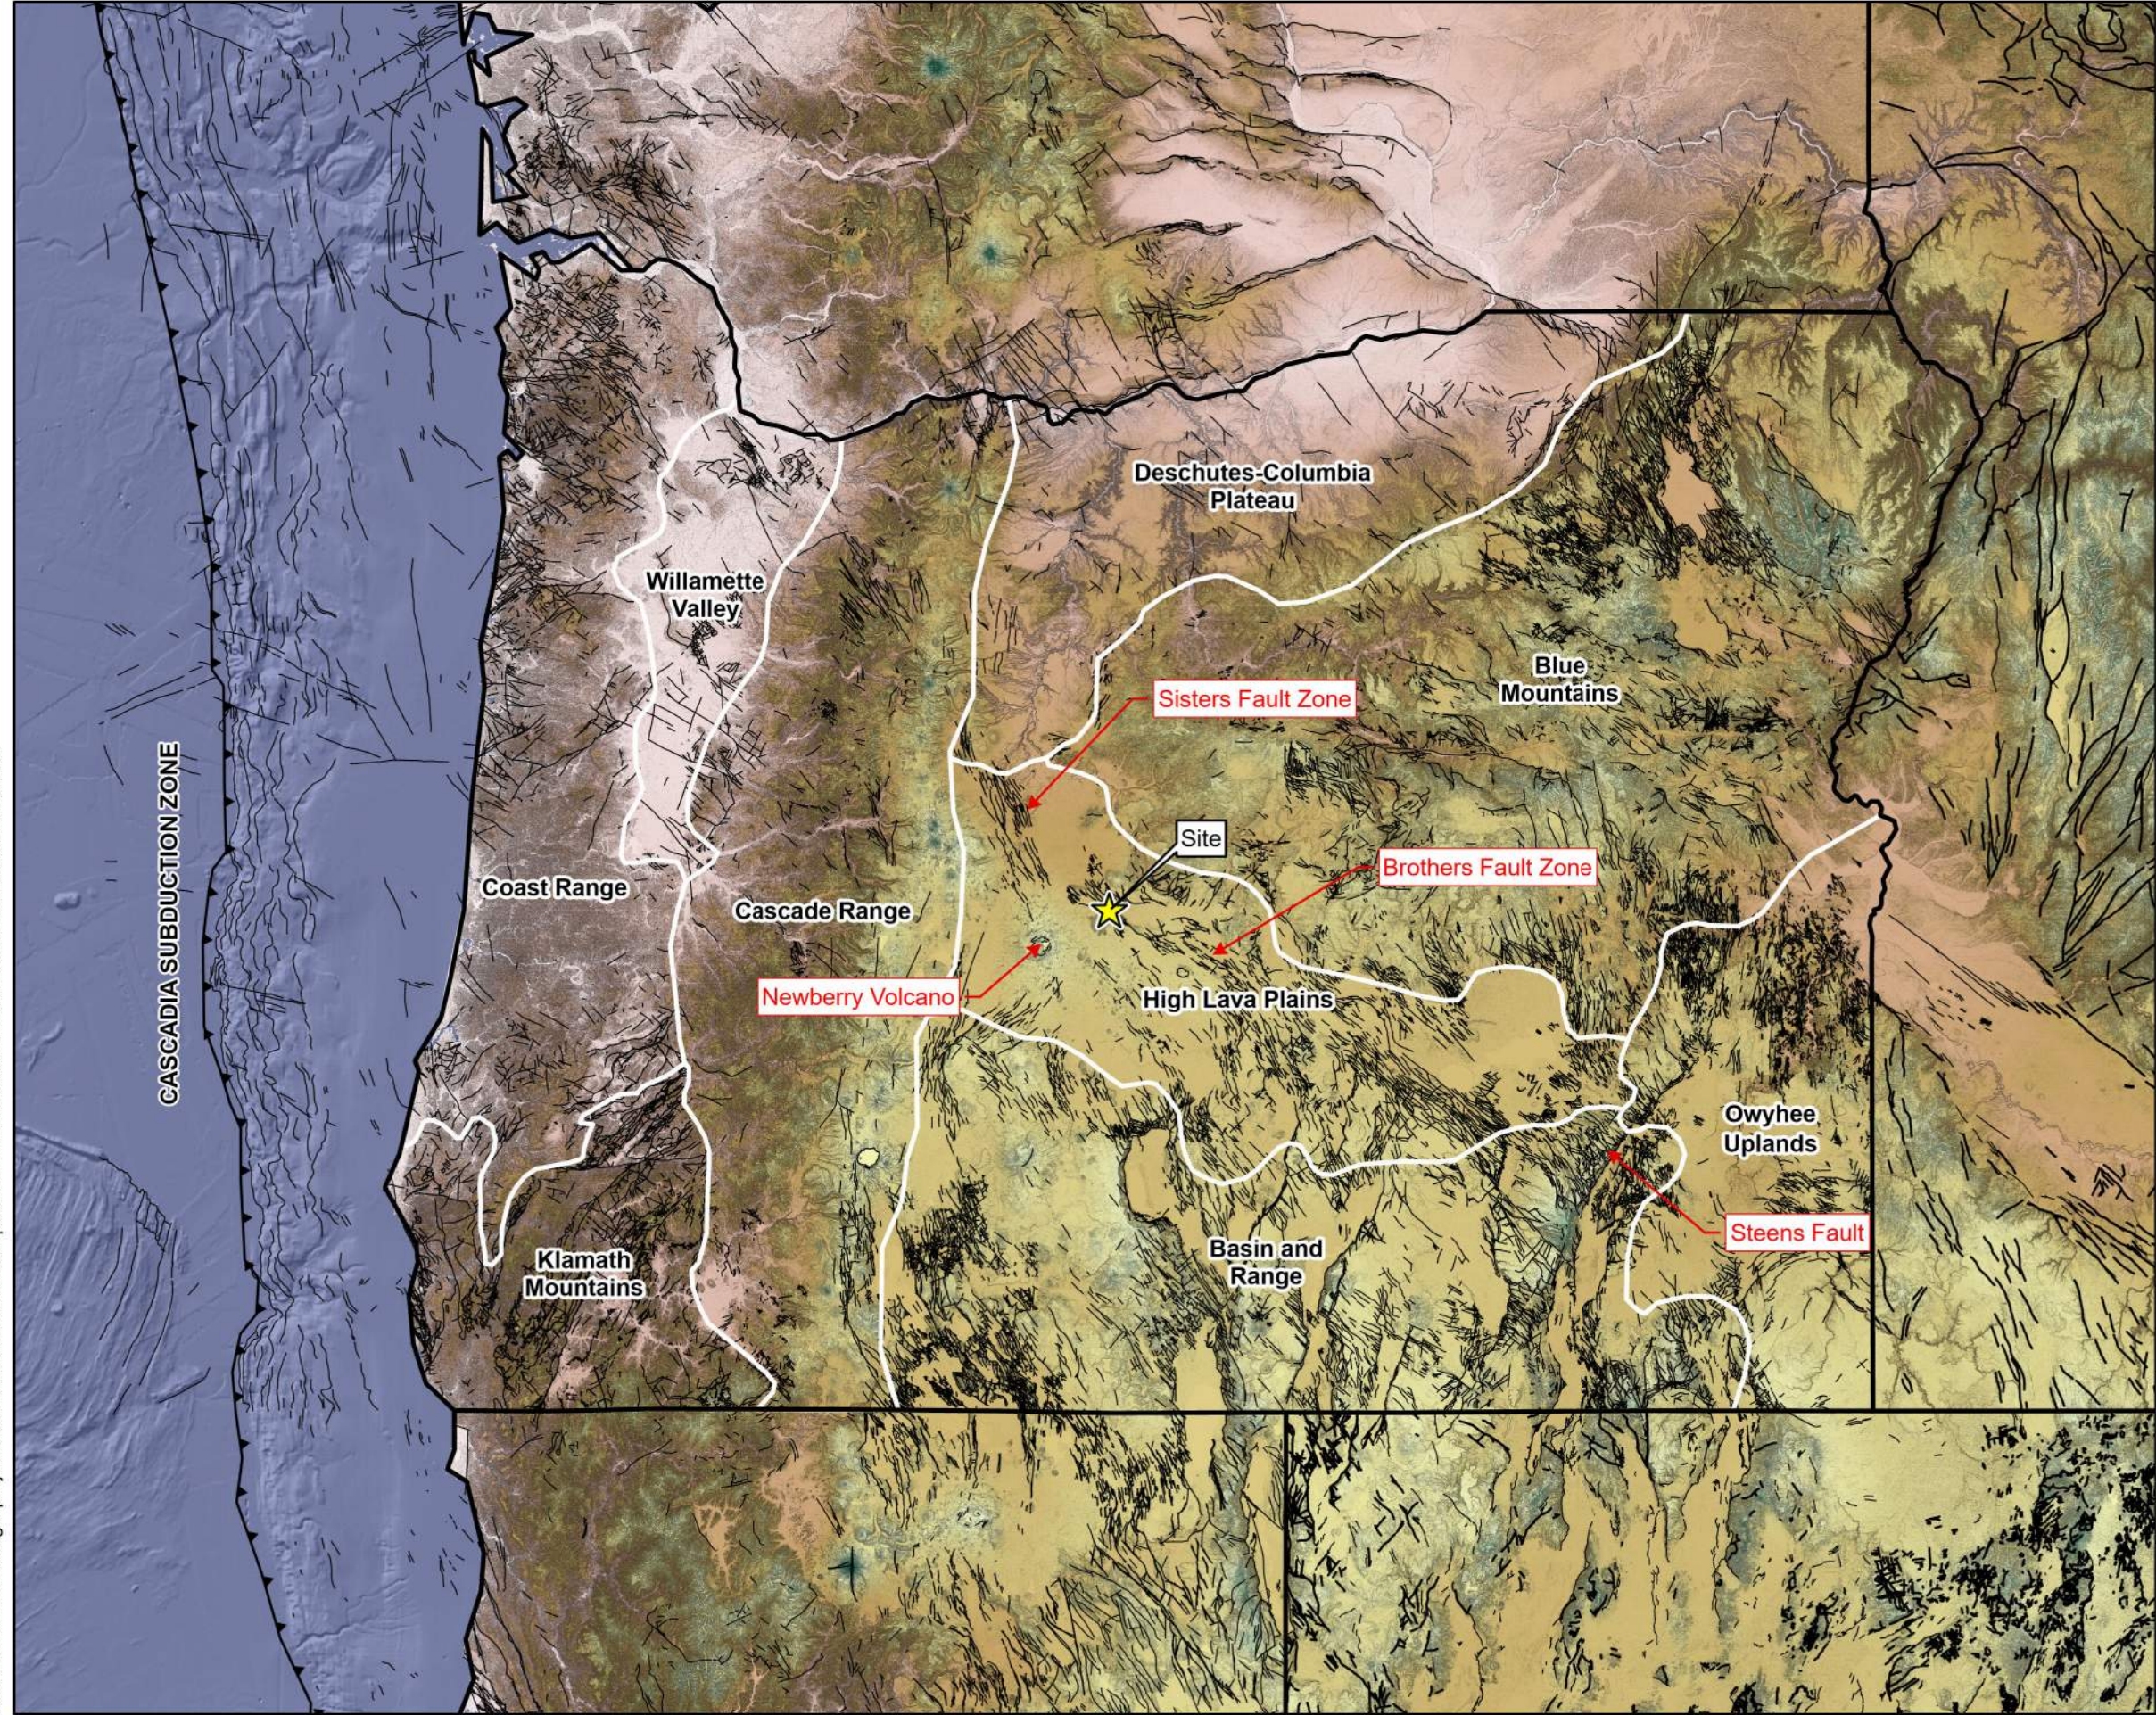
FIGURE  
**2**

- EXPLANATION**
- ★ Site location
  - Cascadia Subduction Zone (CSZ)
  - Fault - Age undifferentiated

- Notes:
1. SRTM 30-meter elevation model
  2. Faults compiled from USGS Quaternary Fault and Fold database, DOGAMI OGDC-7 (2020), WA DNR DS-18 (2019), USGS OFR-2005-1305 (2007), IGS M-9 (2012)
  3. Cascadia Subduction Zone geometry obtained from USGS Cascadia Subduction Zone database (2022)

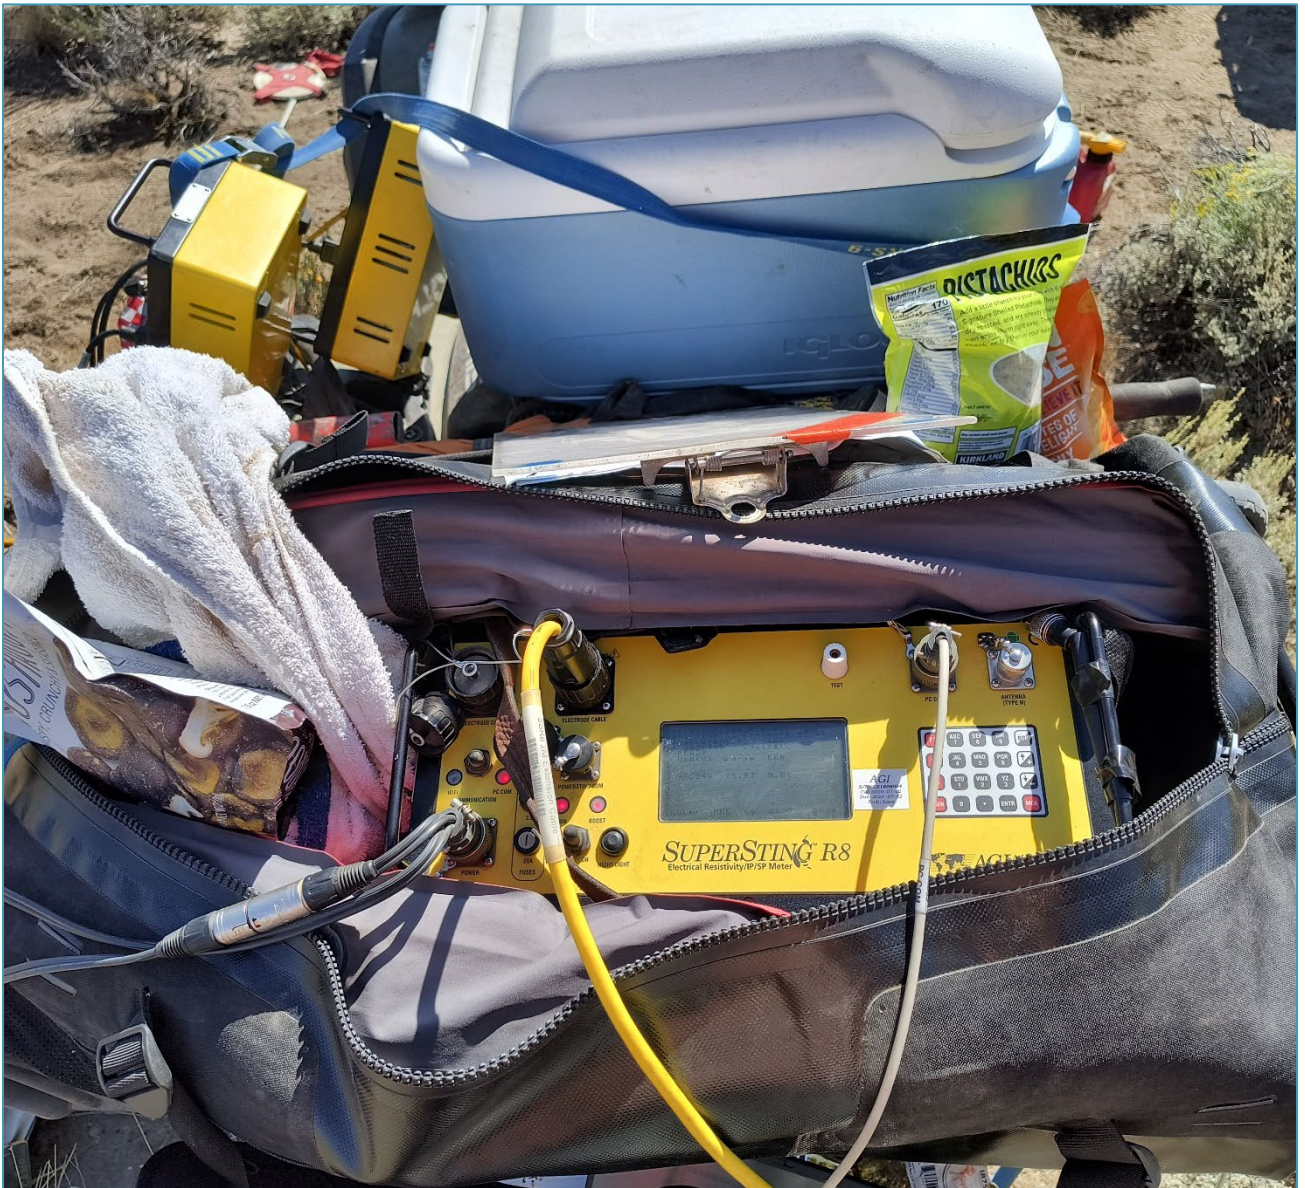
Measurement in an electrical survey involves injecting direct current (DC) through two current-carrying electrodes and measuring the resulting voltage difference at two or more potential electrodes. The apparent resistivity is calculated using the value of the injected current, the voltage measured, and a geometric factor related to the arrangement of the four electrodes.

The investigation depth of any measurement is related to the spacing between the electrodes that inject current. Therefore, sampling at different depths can be done by changing the spacing between the electrodes. Measurements are repeated along a survey line with various combinations of electrodes and spacing to produce an inverted resistivity cross-section (tomogram). In this case, SA merged data from two

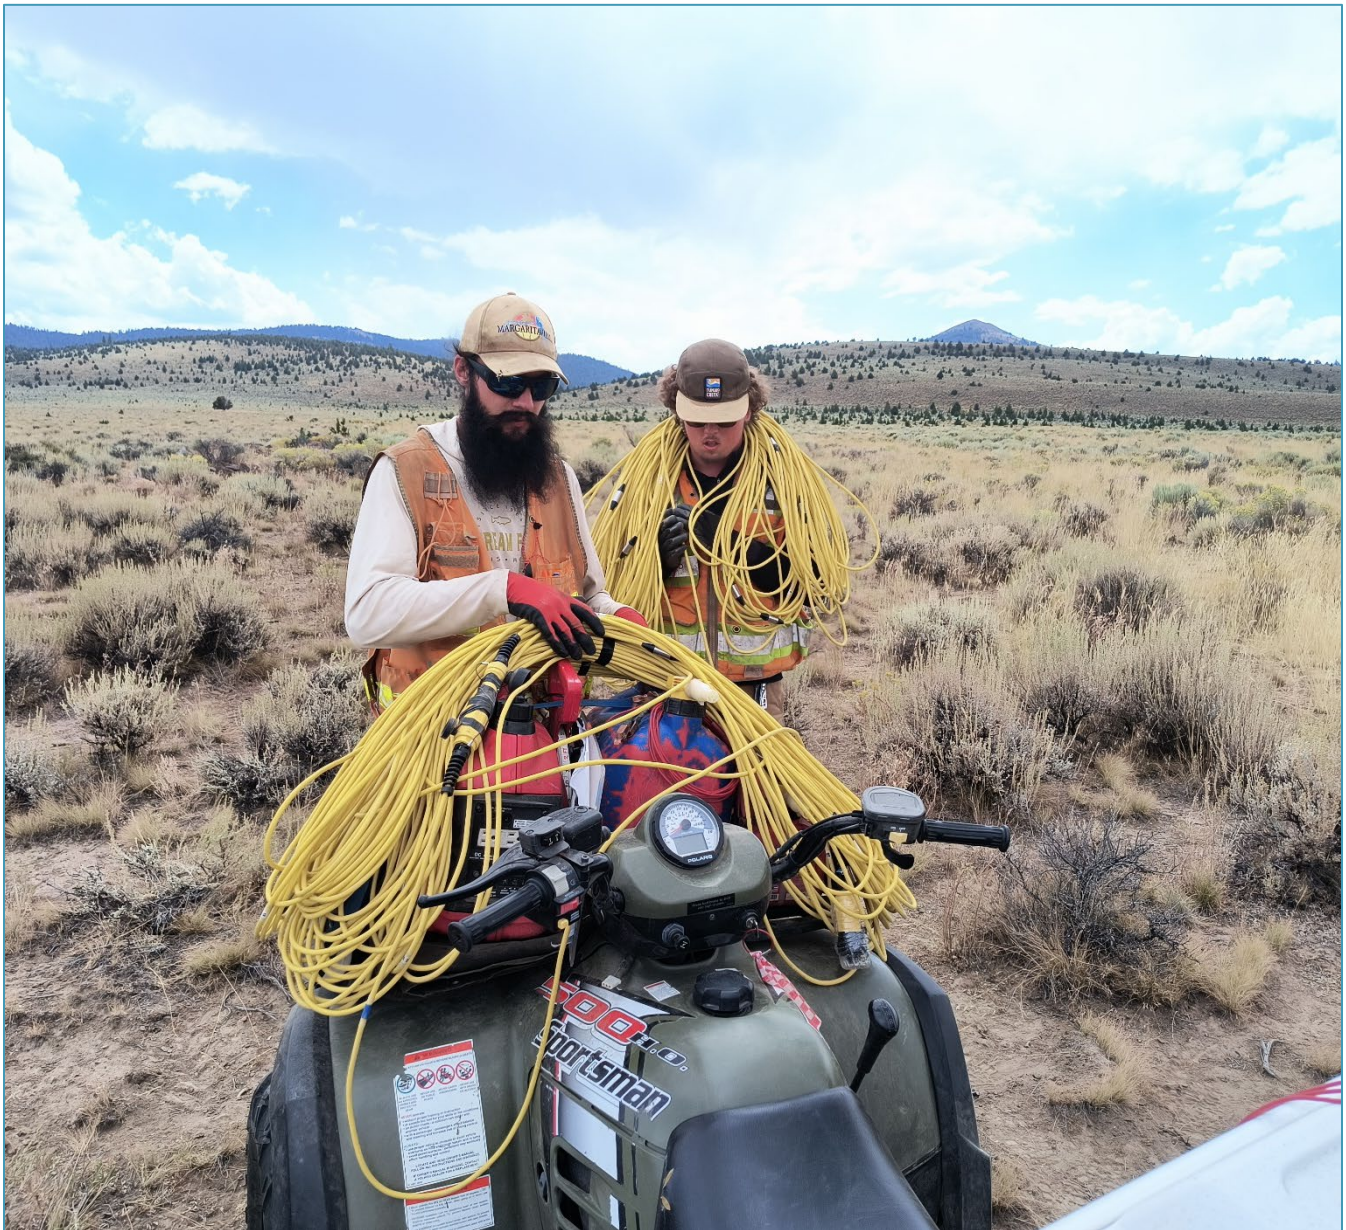
Electrical resistivity data were recorded using an R-8 SuperSting with Wi-Fi manufactured by Advanced Geosciences, Inc., Austin, Texas, USA. The instrument is an eight channel, automated system capable of completing several thousand measurements per hour. For this project, the measurement sequence was configured for high-density data sets and data were cautiously filtered during the processing stage.

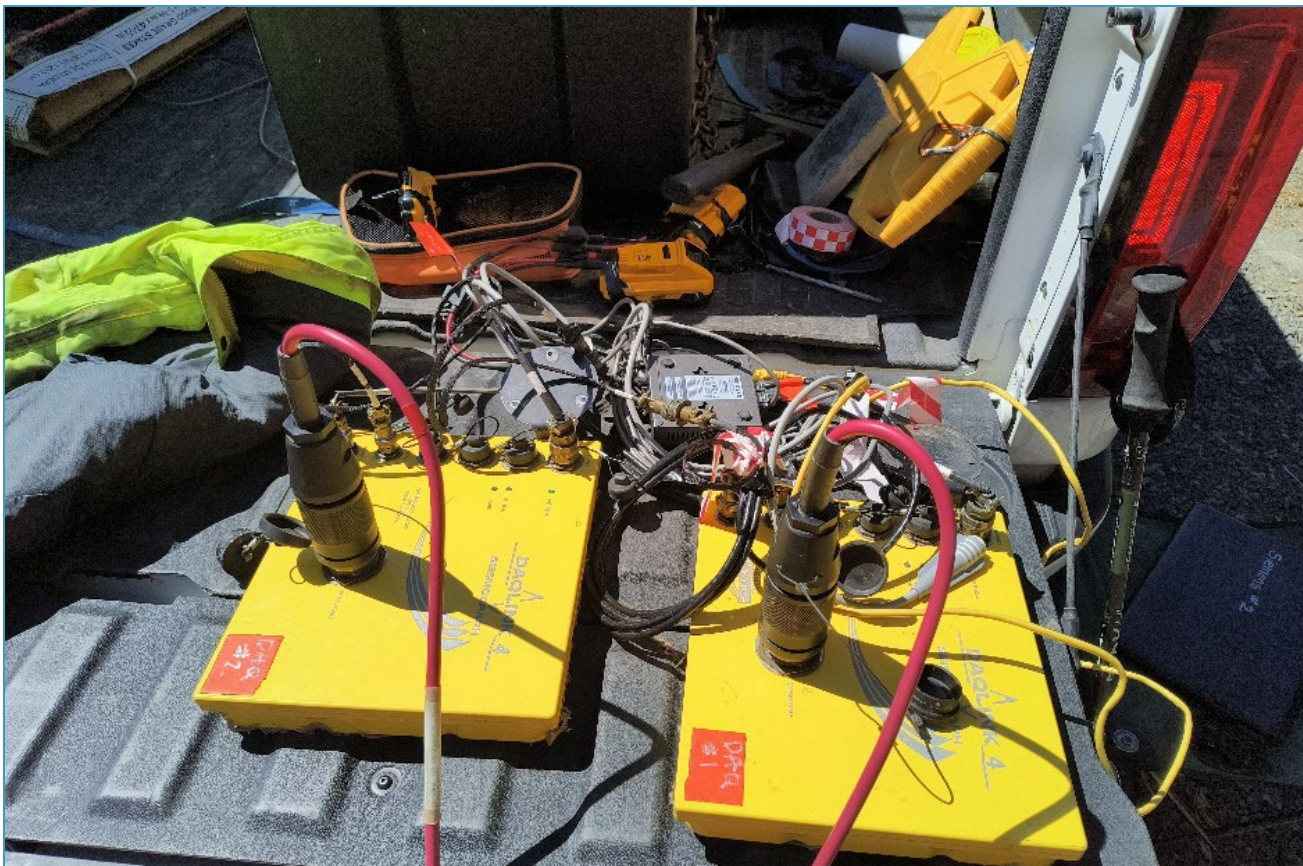
**How it works:** When the charge is detonated, the receivers are activated and the wavelet energy is recorded. The P-wave is the fastest of the various seismic waves generated and only the time of the first arrival P-wave at the receiver is considered in the SR method. These first arrivals are picked for each shot at each receiver. As the energy travels through the ground, the waves are refracted and the arrival time, combined with distance from the source, is related to both the velocity and distance to the layers promoting refraction. This distance is not necessarily vertical depth; rather the nearest refractor and the image can be skewed when oriented along a dipping refractor. This effect can be appeased by surveys that employ mutually perpendicular lines.

Data were recorded using networked DAQ 4 seismographs manufactured by Seismic Source in Ponca City, Oklahoma, USA, connected to an IBM computer laptop. The lines were set up with receiver spacing of 20 feet for greater depth of exploration and

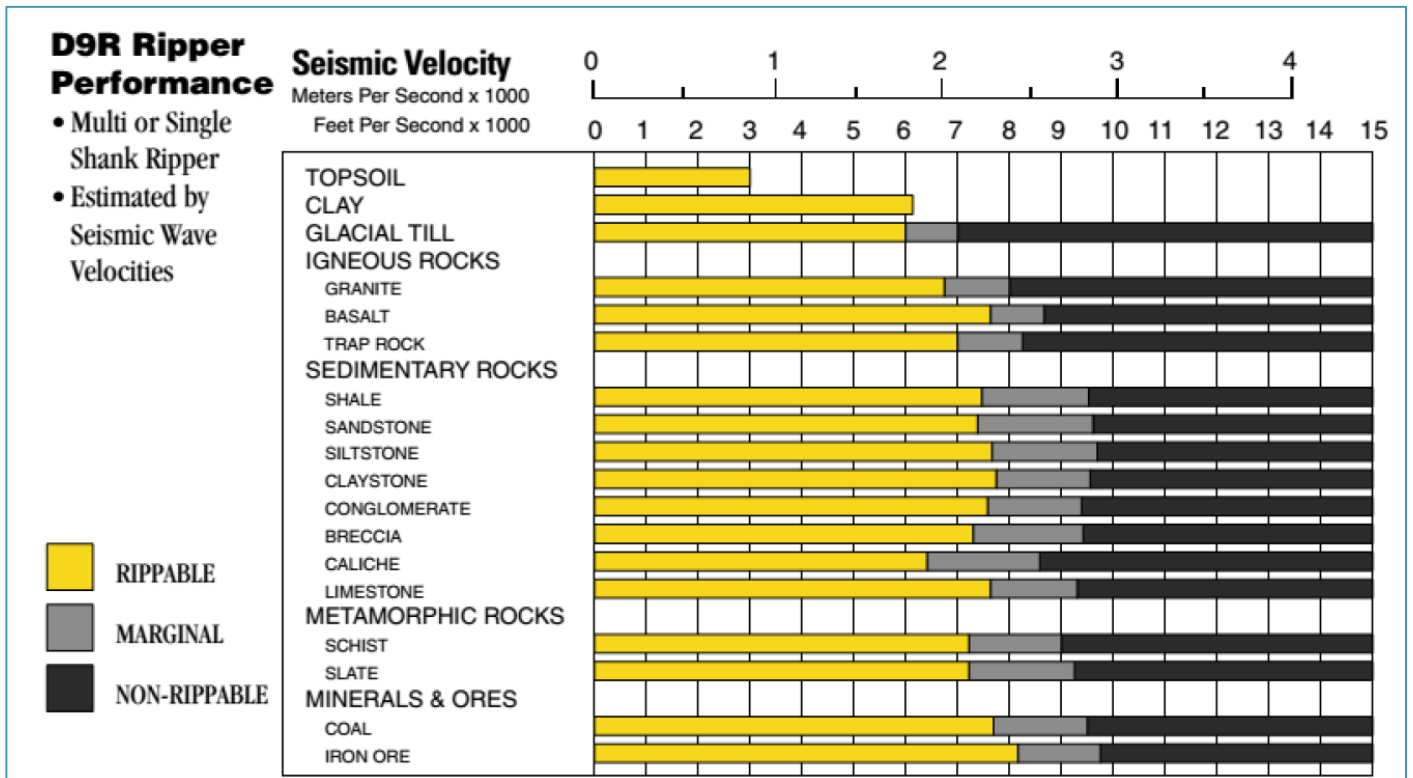
To provide an understanding of the excavation characteristics of this thick unconsolidated layer, SA presents findings published by Caterpillar Inc. describing excavation characteristics relative to P-wave velocity and various types of rock and soil:

The chart presents simplistic material descriptions and many uncertainties, albeit the P-wave velocities interpreted at Roth East are typically at or below 4000 ft/s within the upper 200 feet suggesting successful excavation using rippers and/or powerful excavators.
