## Preliminary Geotechnical Feasibility Report

## Phase 2 Final SWMF Site Evaluation – Moon Pit

### **Preliminary Geotechnical Feasibility Report**

February 2024

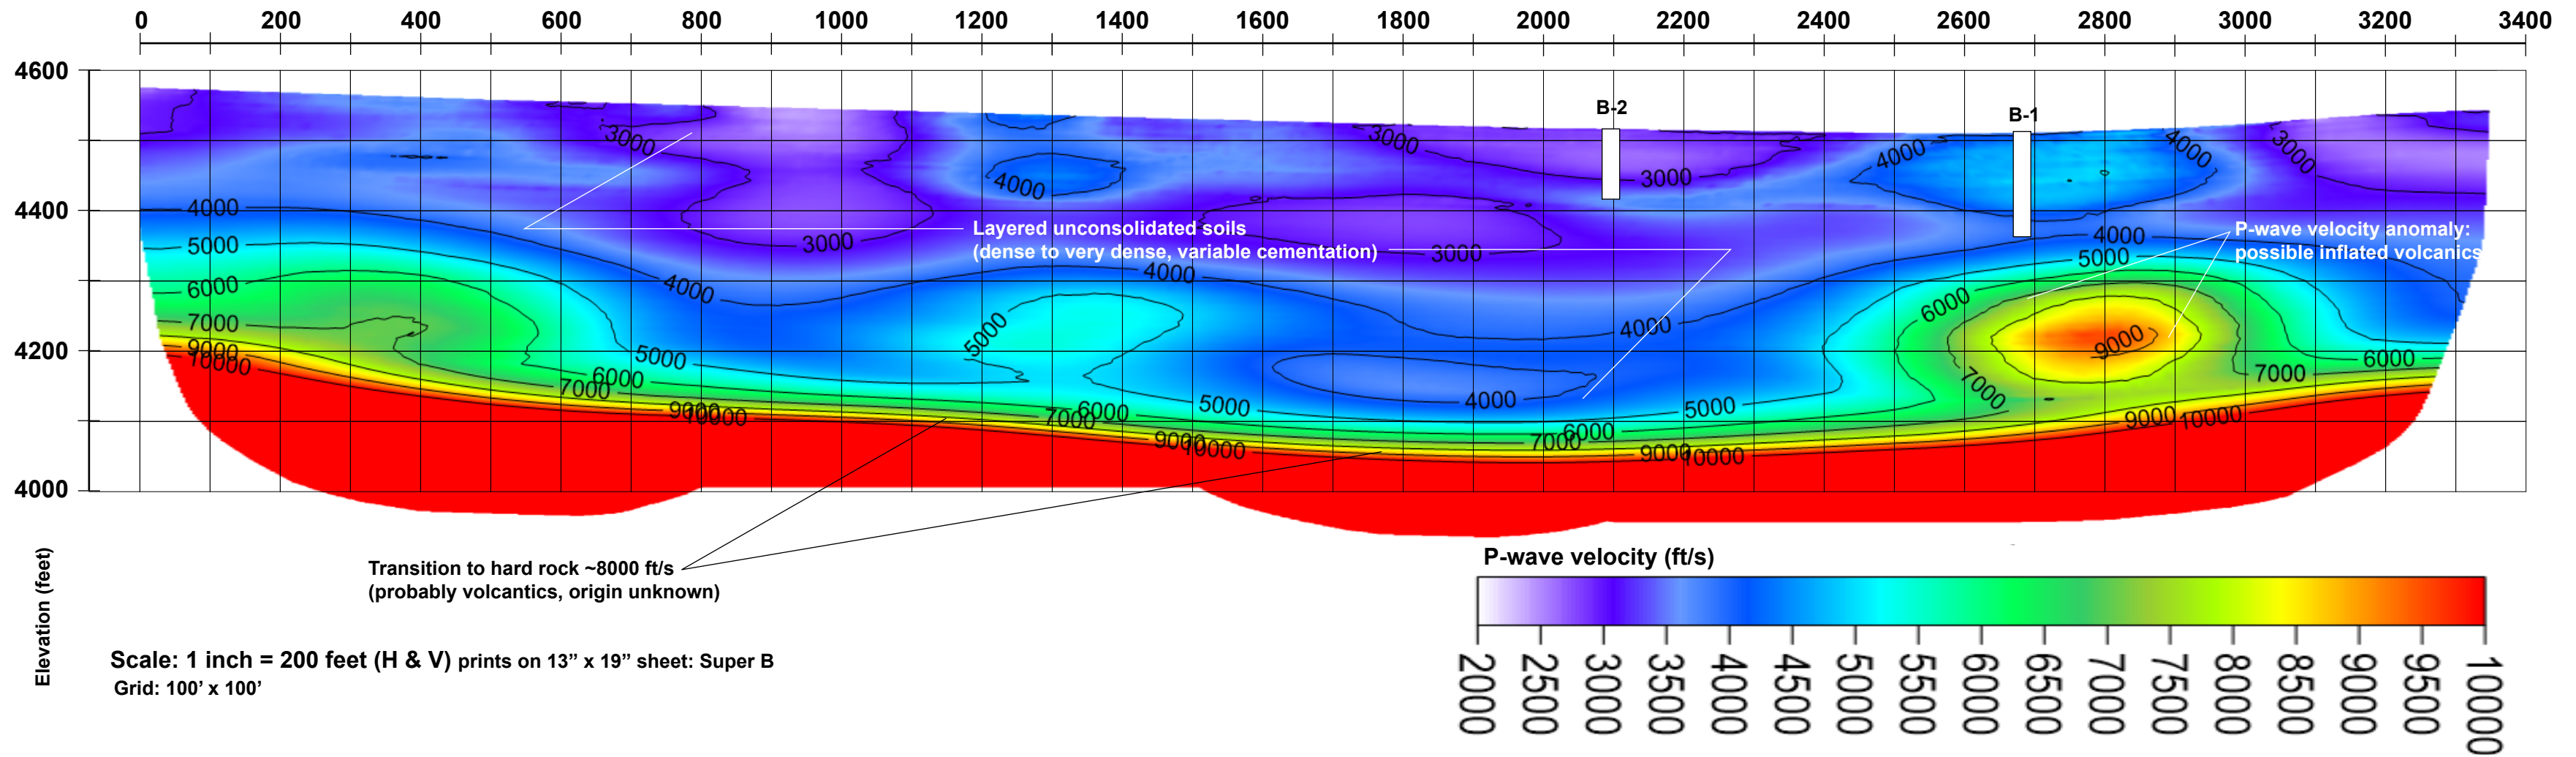
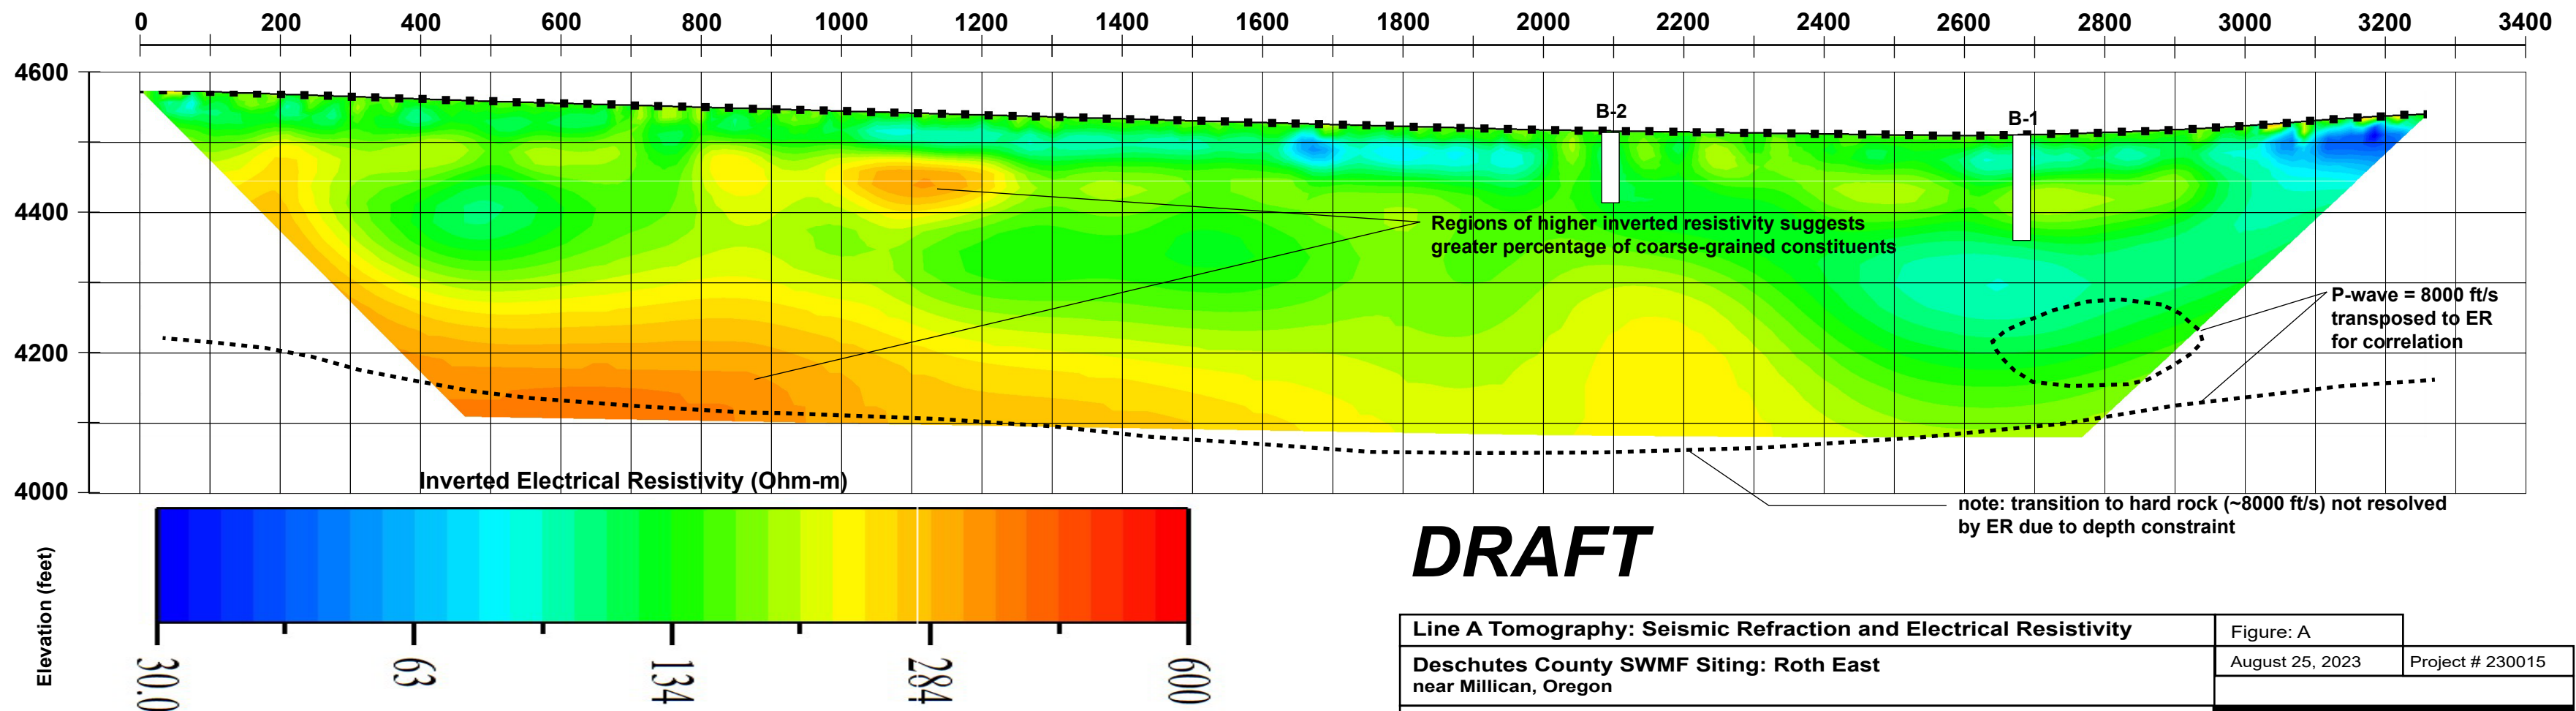
# Electrical Resistivity Tomography: Line A

(98 electrodes on 10.25 m spacing: combined Dipole-Dipole and Strong Gradient arrays)

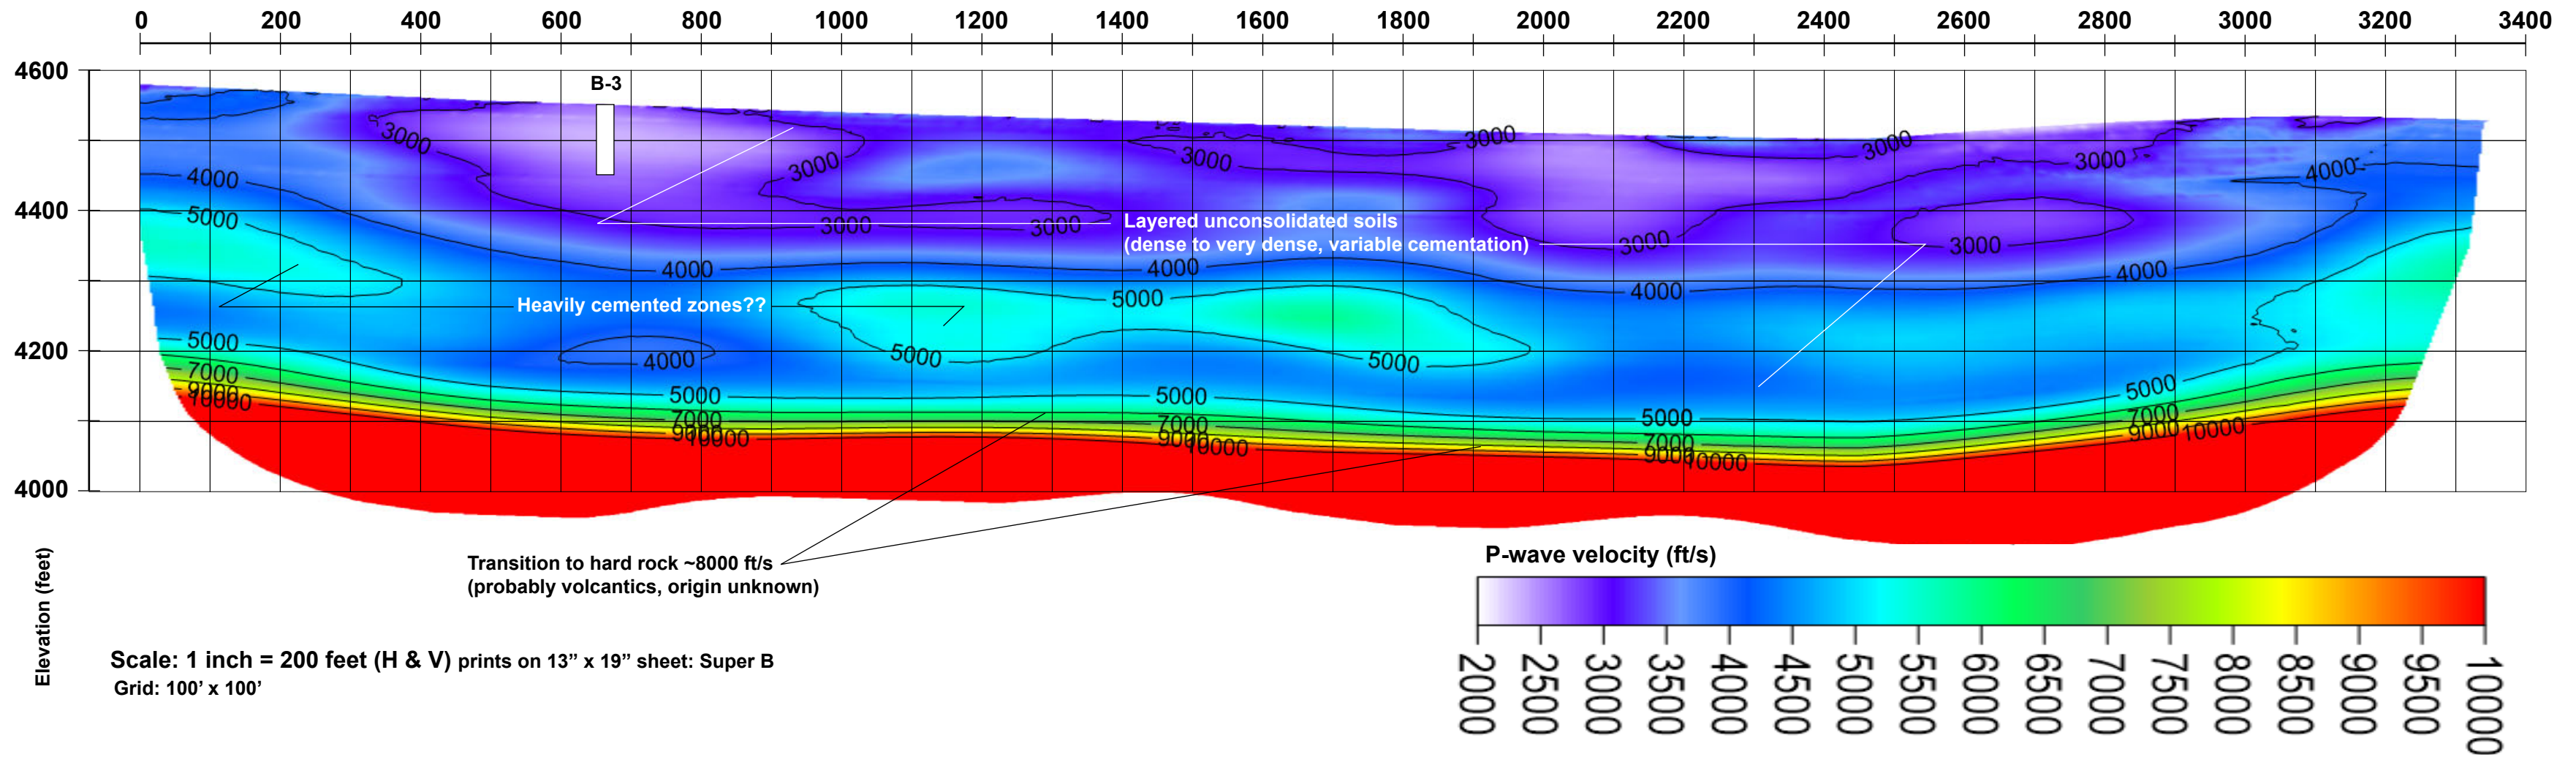
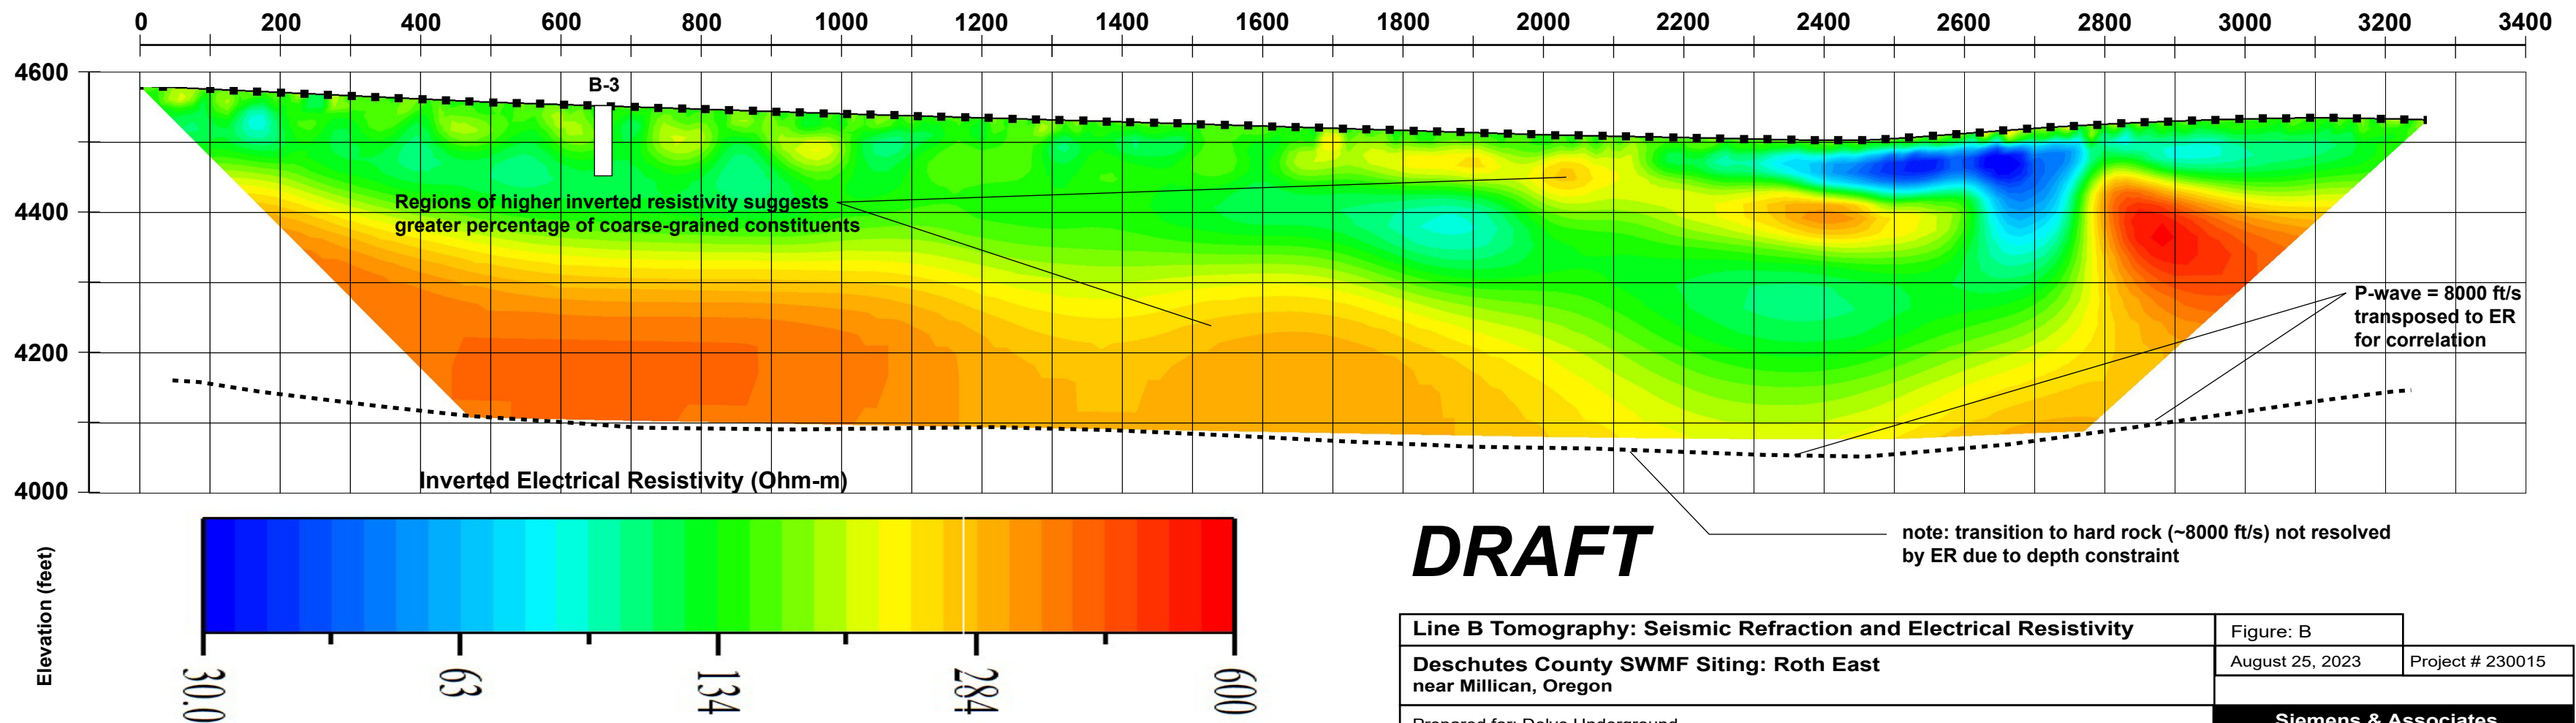
# Electrical Resistivity Tomography: Line B

(98 electrodes on 10.25 m spacing: combined Dipole-Dipole and Strong Gradient arrays)
